An Taisce
The National Trust for Ireland

Buildings at Risk

November 2014

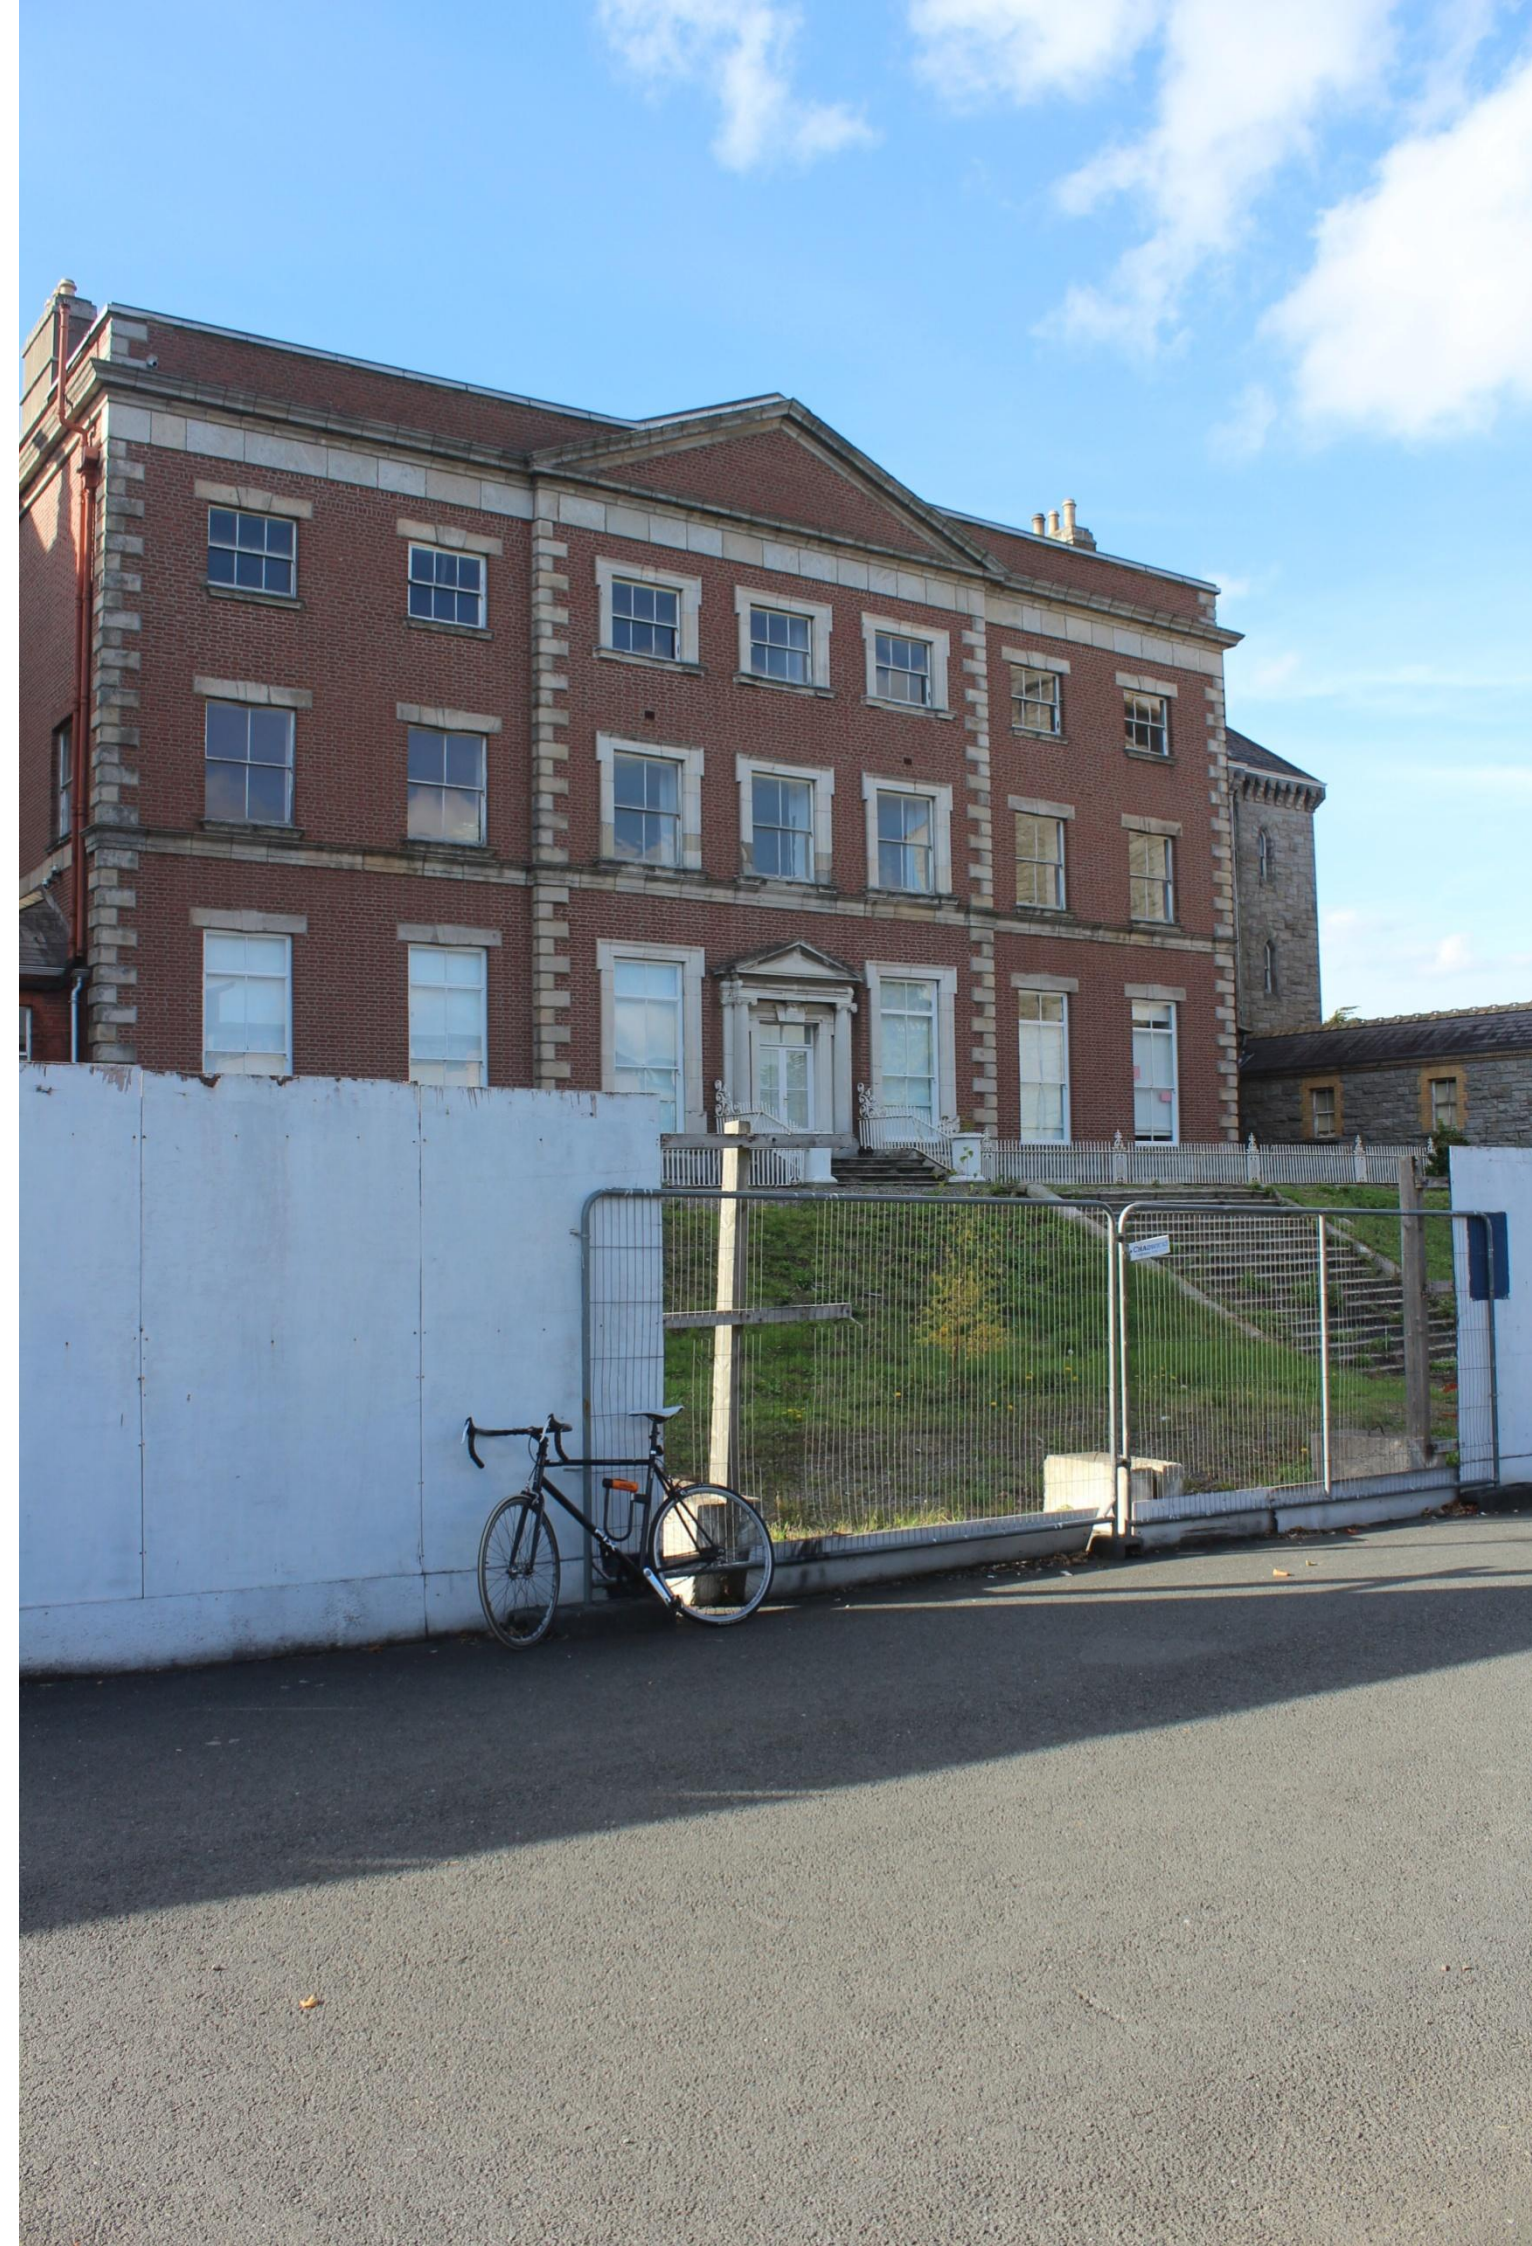
St Columba's Church

Vacant with no identified new use	X
Suffering from neglect and/or poor maintenance	
Suffering from structural problems	
Fire damaged	
Threatened with demolition	
Ruin which is poorly maintained

Condition of Structure	Fair
Level of Risk	Moderate

Although previously in good condition, it now requires repairs. There are signs of increasing conservation problems. There is no immediate danger of collapse but condition is such that unless urgent remedial works are carried out the building will sharply deteriorate.

St Columba's is an early 19th century Church of Ireland parish church on ancient monastic site adjoining round tower incorporated into medieval structure. The church has vacated the structure following loose plaster which fell into area over font. Complex remedial works now required. The structures are of significant historic importance and require conservation works to prevent further deterioration.

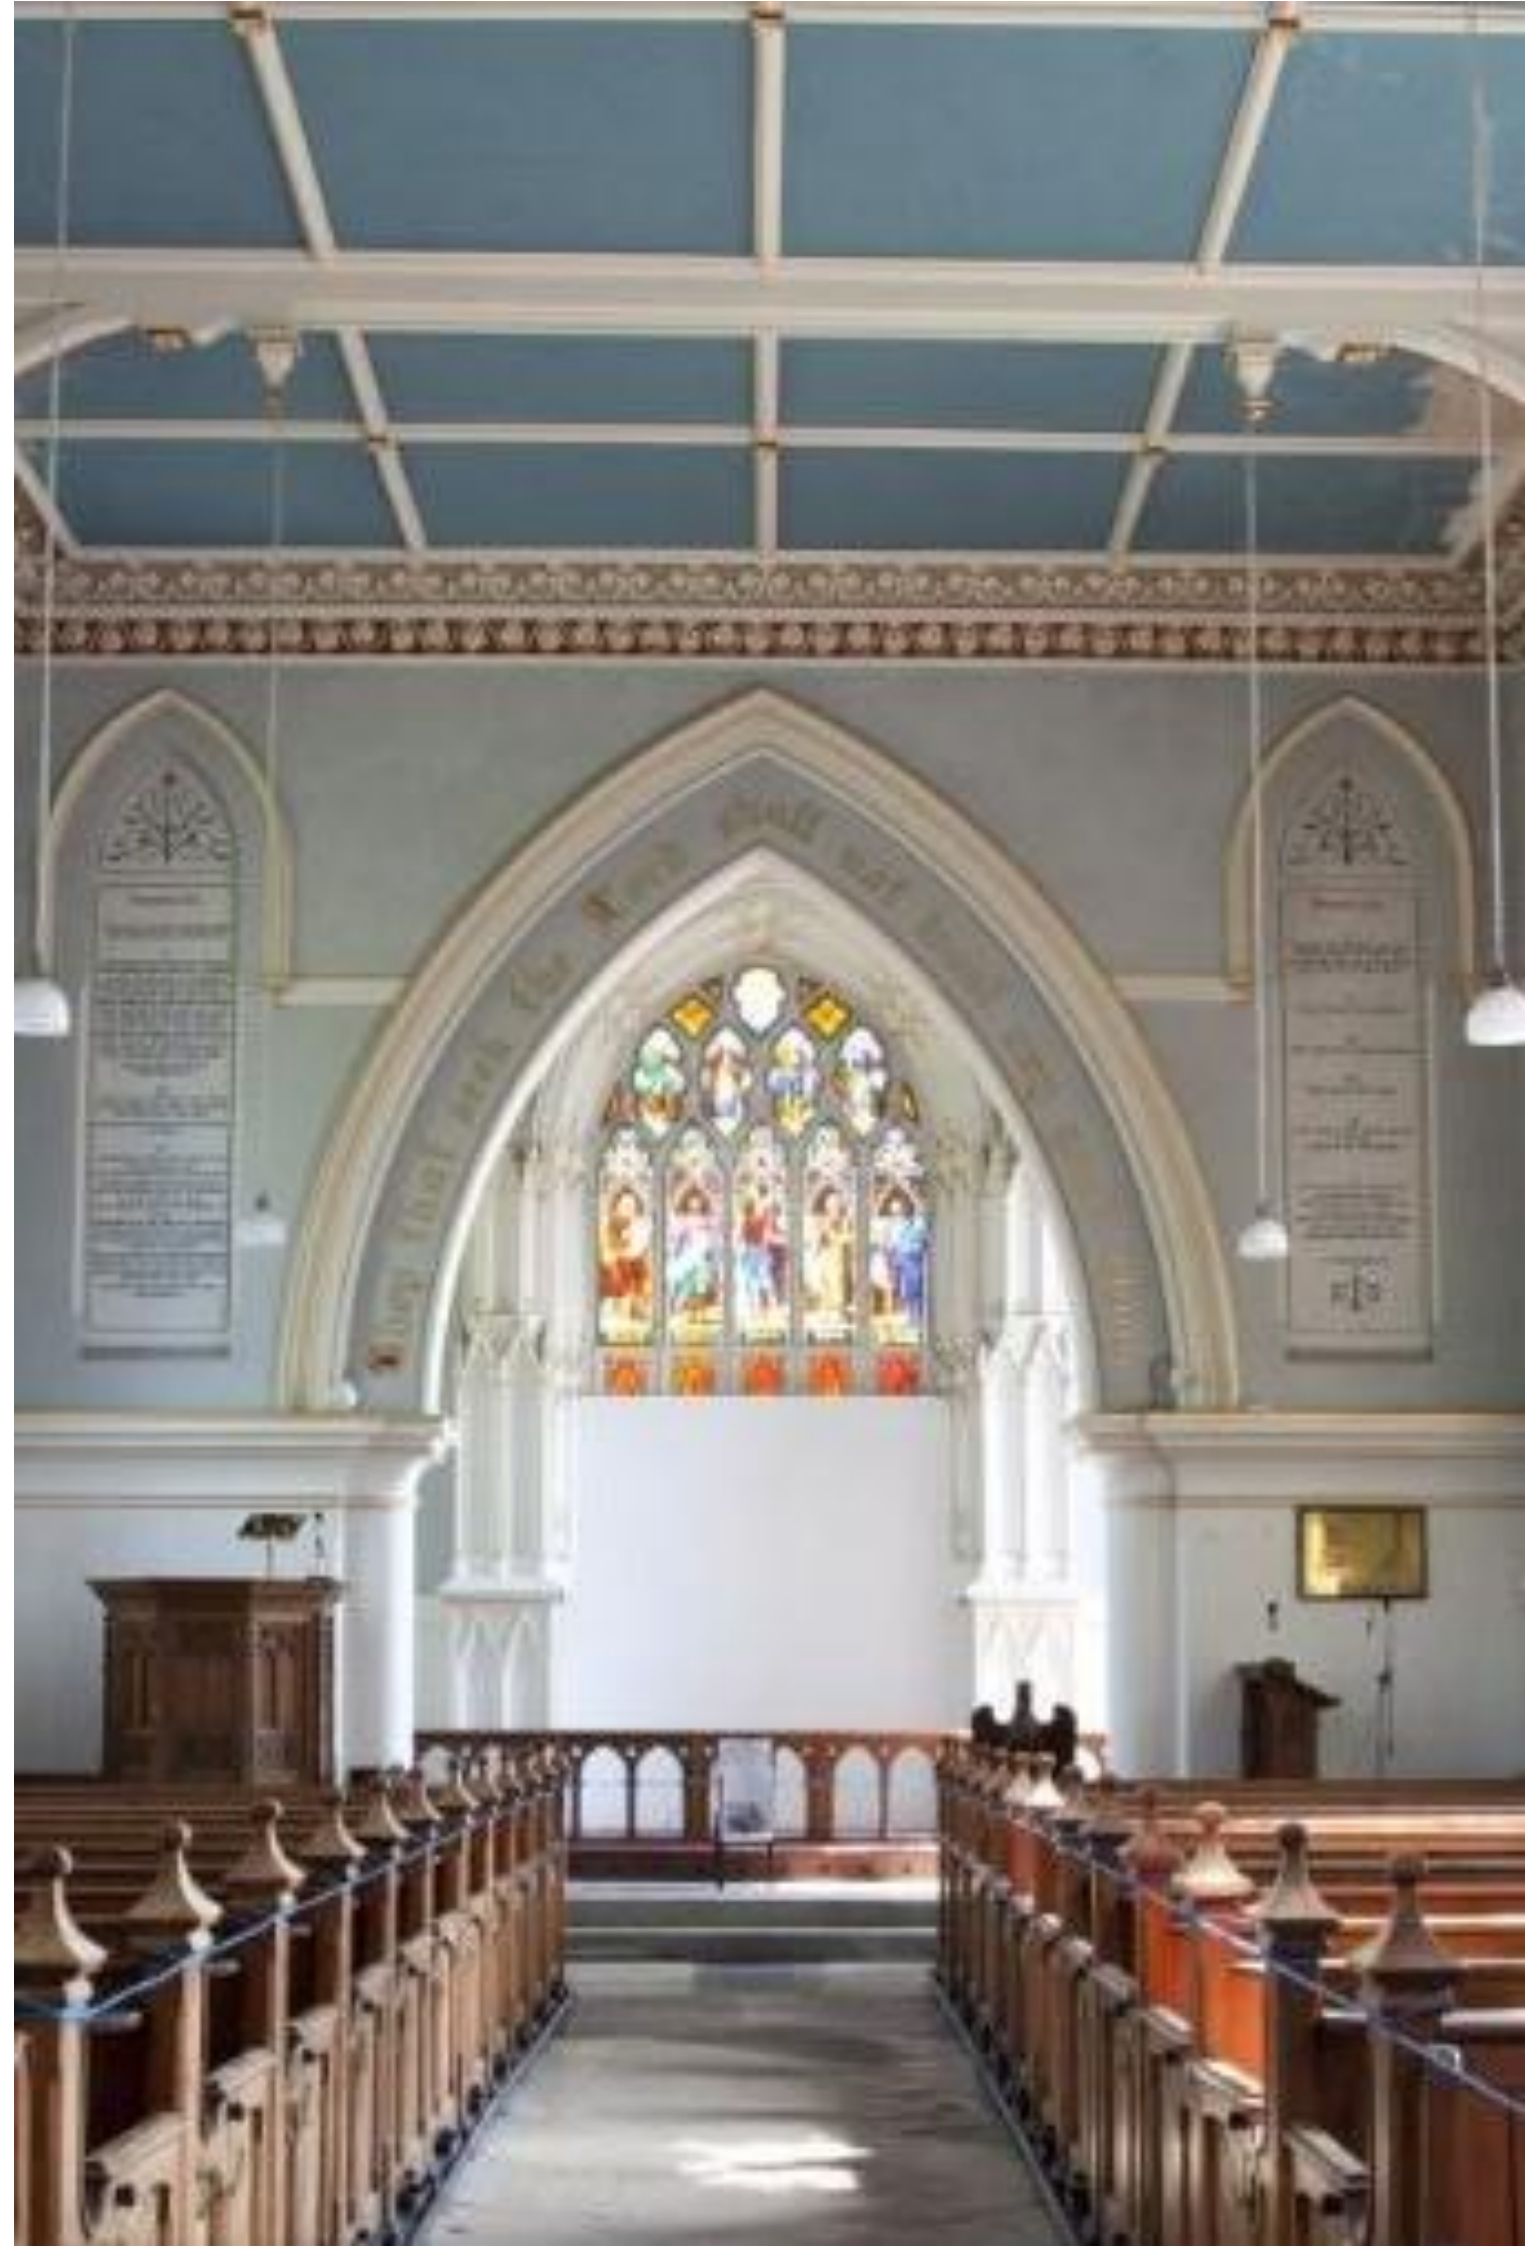
Saint Brigid's Hospital

Vacant with no identified new use	X
Suffering from neglect and/or poor maintenance	X
Suffering from structural problems	
Fire damaged	
Threatened with demolition	
Ruin which is poorly maintained

Condition of Structure	Poor
Level of Risk	High

Sections of this building have been vacant for a number of years and it does not appear to be maintained particularly the eastern wings. Most of the external fabric remains, but there are obvious signs of deterioration. There is no immediate danger of collapse but the condition is such that unless urgent remedial works are carried out the building will sharply deteriorate.

The unusual X shaped building served as an asylum until 2013 when psychiatric services were removed from Ballinasloe and consolidated in Galway City and Roscommon. There are certain portions of the building still in use but the structure is very large with the HSE struggling to occupy the entire building. This building urgently requires new uses to be identified to prevent further deterioration of its character.

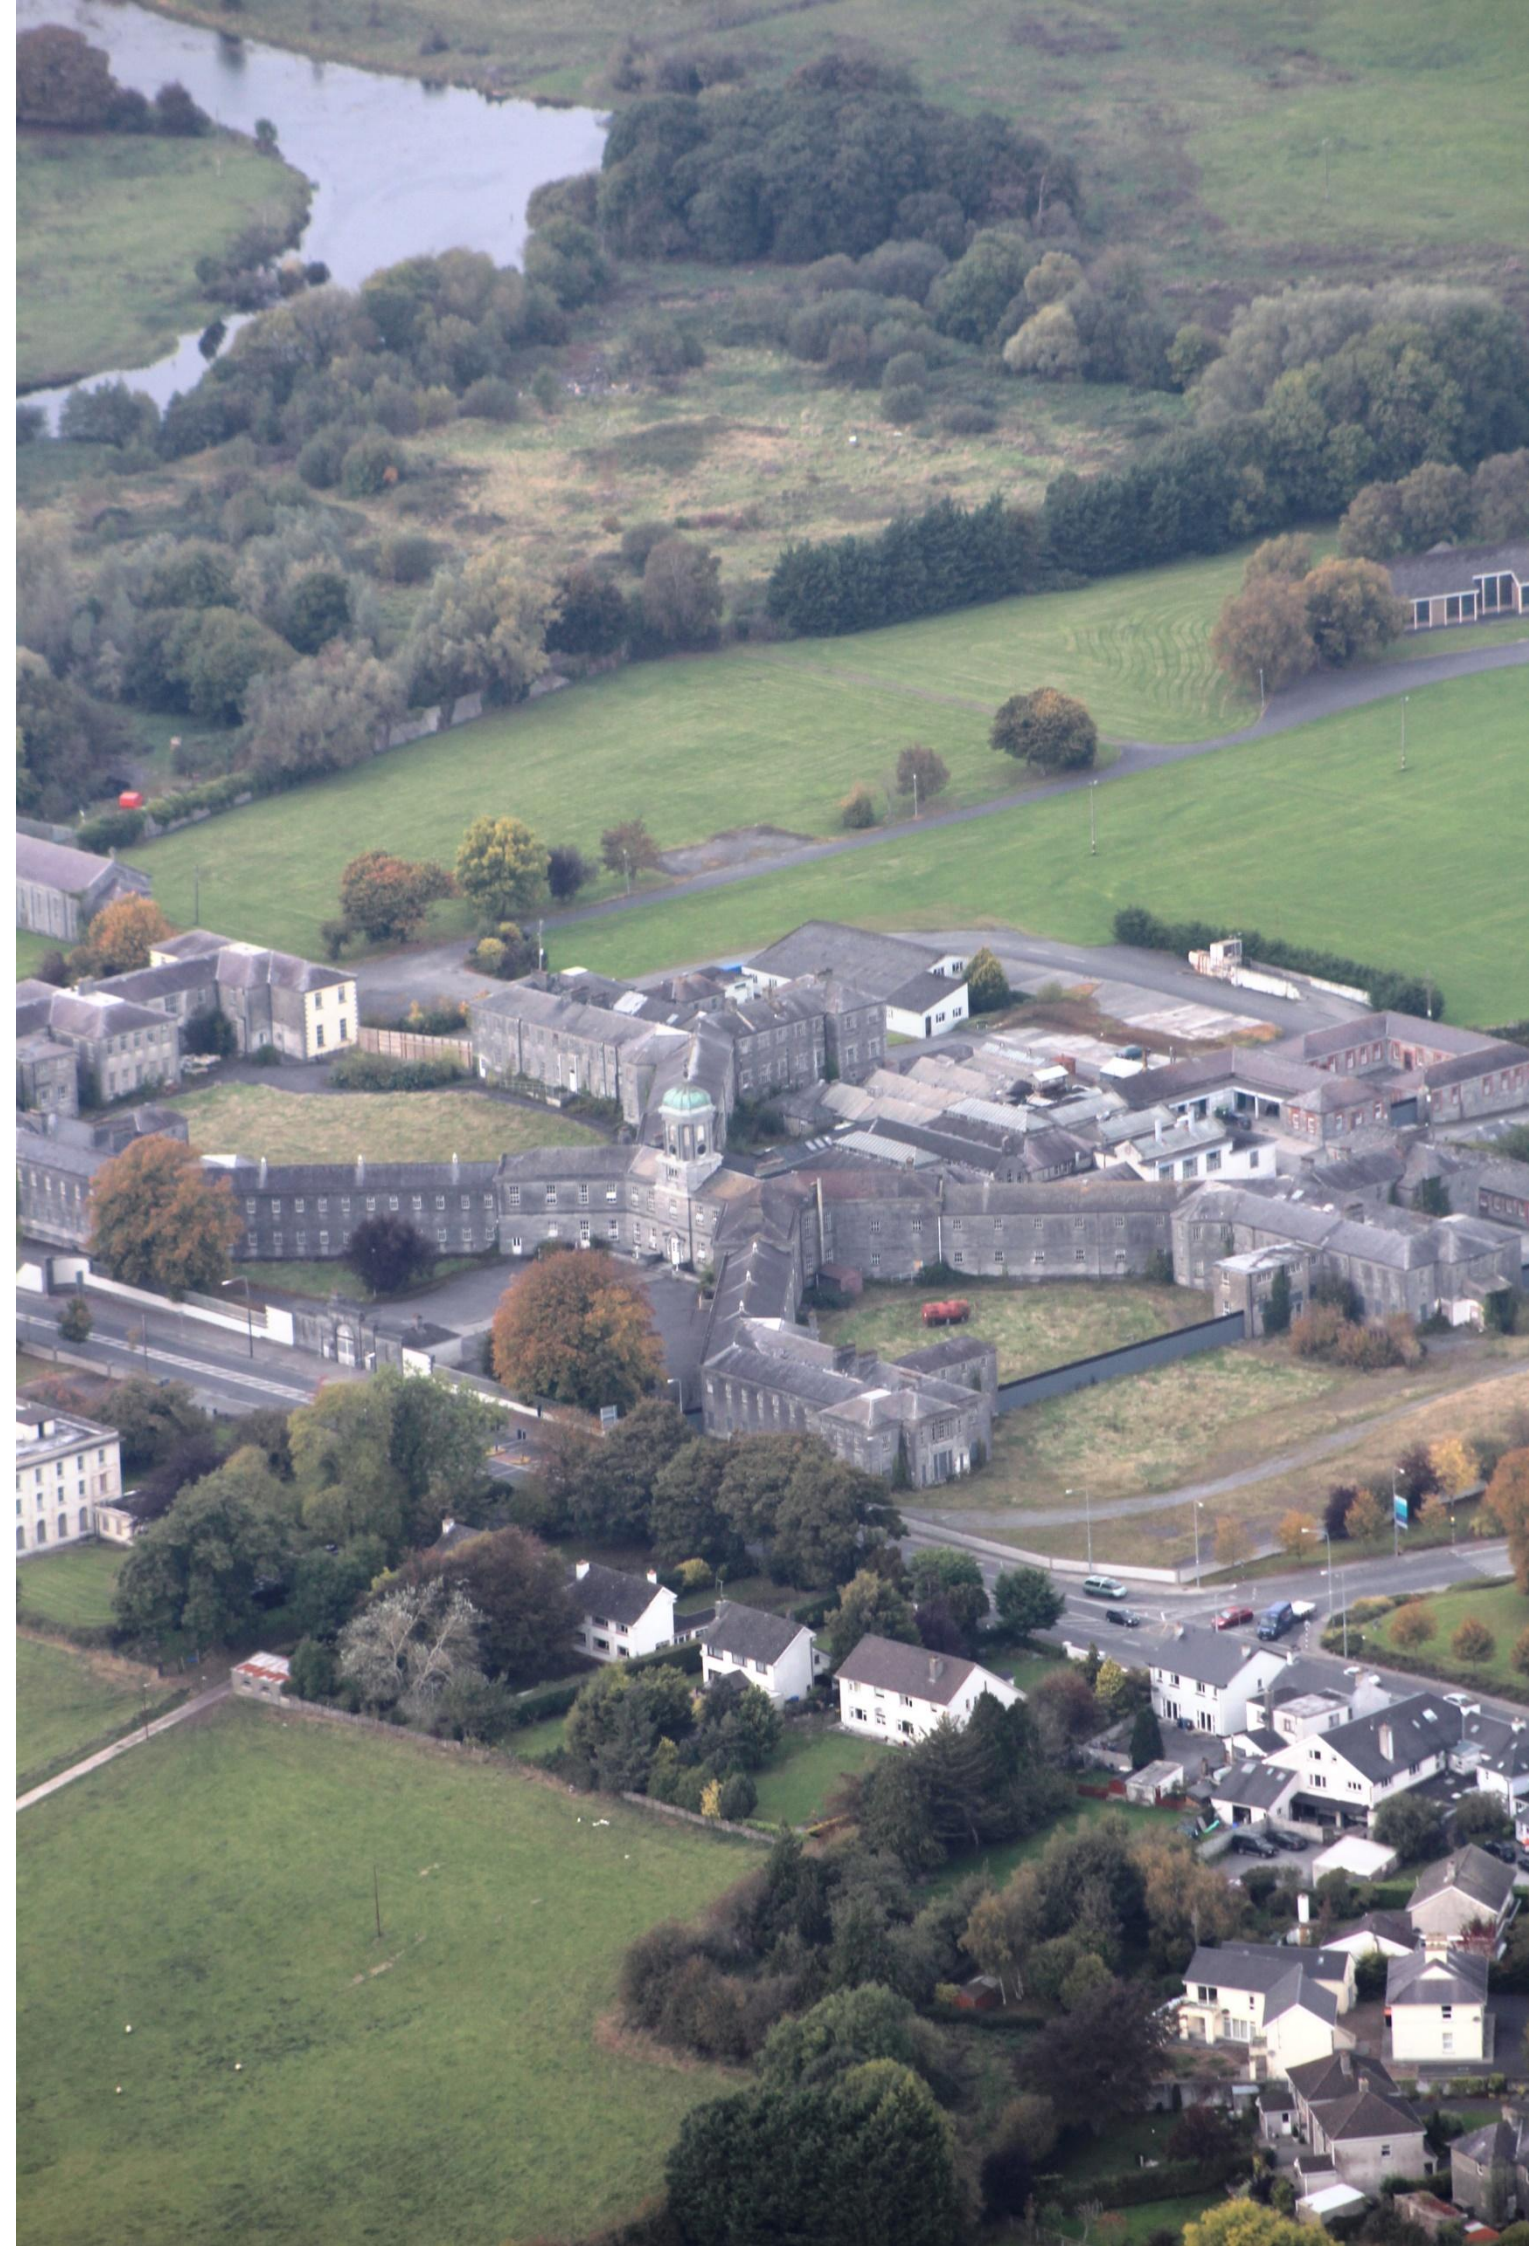
Eyrecourt Castle

Vacant with no identified new use	
Suffering from neglect and/or poor maintenance	X
Suffering from structural problems	
Fire damaged	
Threatened with demolition	
Ruin which is poorly maintained	X

Condition of Structure	Ruinous
Level of Risk	High

The building is a roofless shell. None of the original fabric remains other than the external walls. It is suffering from structural problems that could lead to full or partial collapse, and there is an immediate threat of further deterioration.

Eyrecourt is a significant deteriorating ruin of the mid 17th century. The house was dismantled in the early 20th century when the spectacular staircase was exported to the USA. The structure is of significant historic importance and requires conservation works to prevent further deterioration.

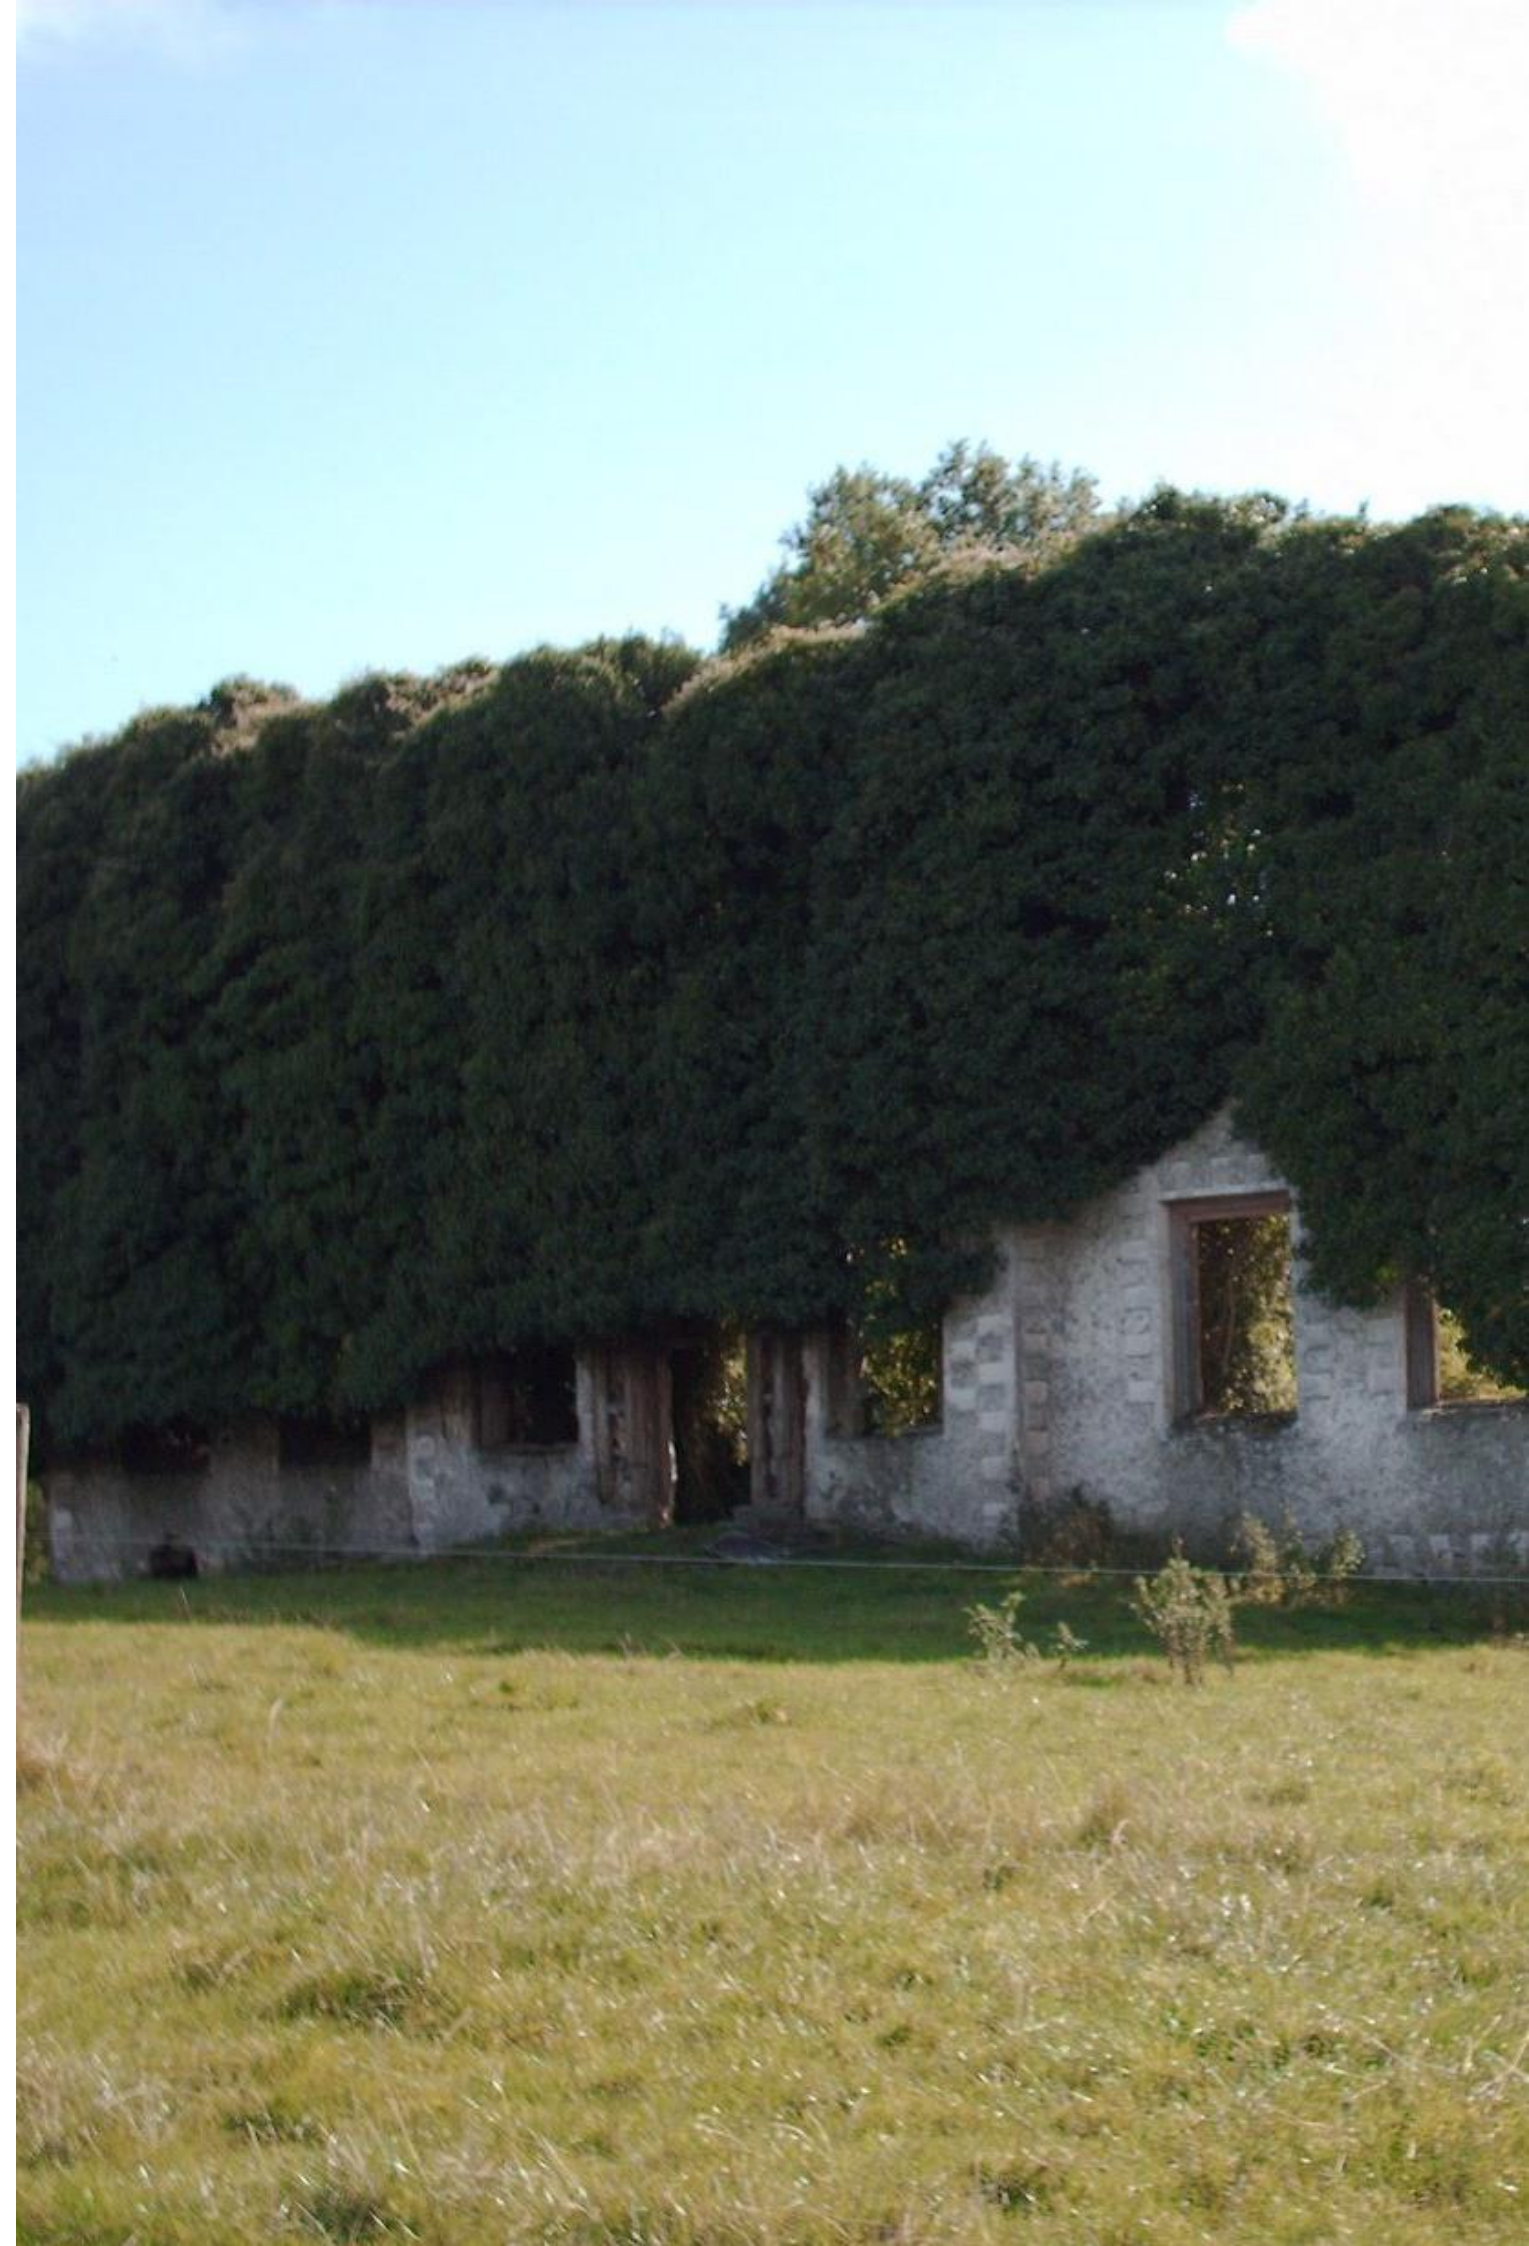
Vacant with no identified new use	
Suffering from neglect and/or poor maintenance	X
Suffering from structural problems	X
Fire damaged	
Threatened with demolition	
Ruin which is poorly maintained	X

Condition of Structure	Ruinous
Level of Risk	High

The building is a roofless shell. None of the original fabric remains other than the external walls. It is suffering from structural problems that could lead to full or partial collapse, and there is an immediate threat of further deterioration.

Tyrone House is a dramatic shell of late 19th century house of the St George Family. It was abandoned to ruin in the early 20th century. It inspired the Somerville and Ross novel 'The Big House of Inver'. It is now one of the most evocative of Irish house ruins. The structure is of significant historic importance and requires conservation works to prevent further deterioration.

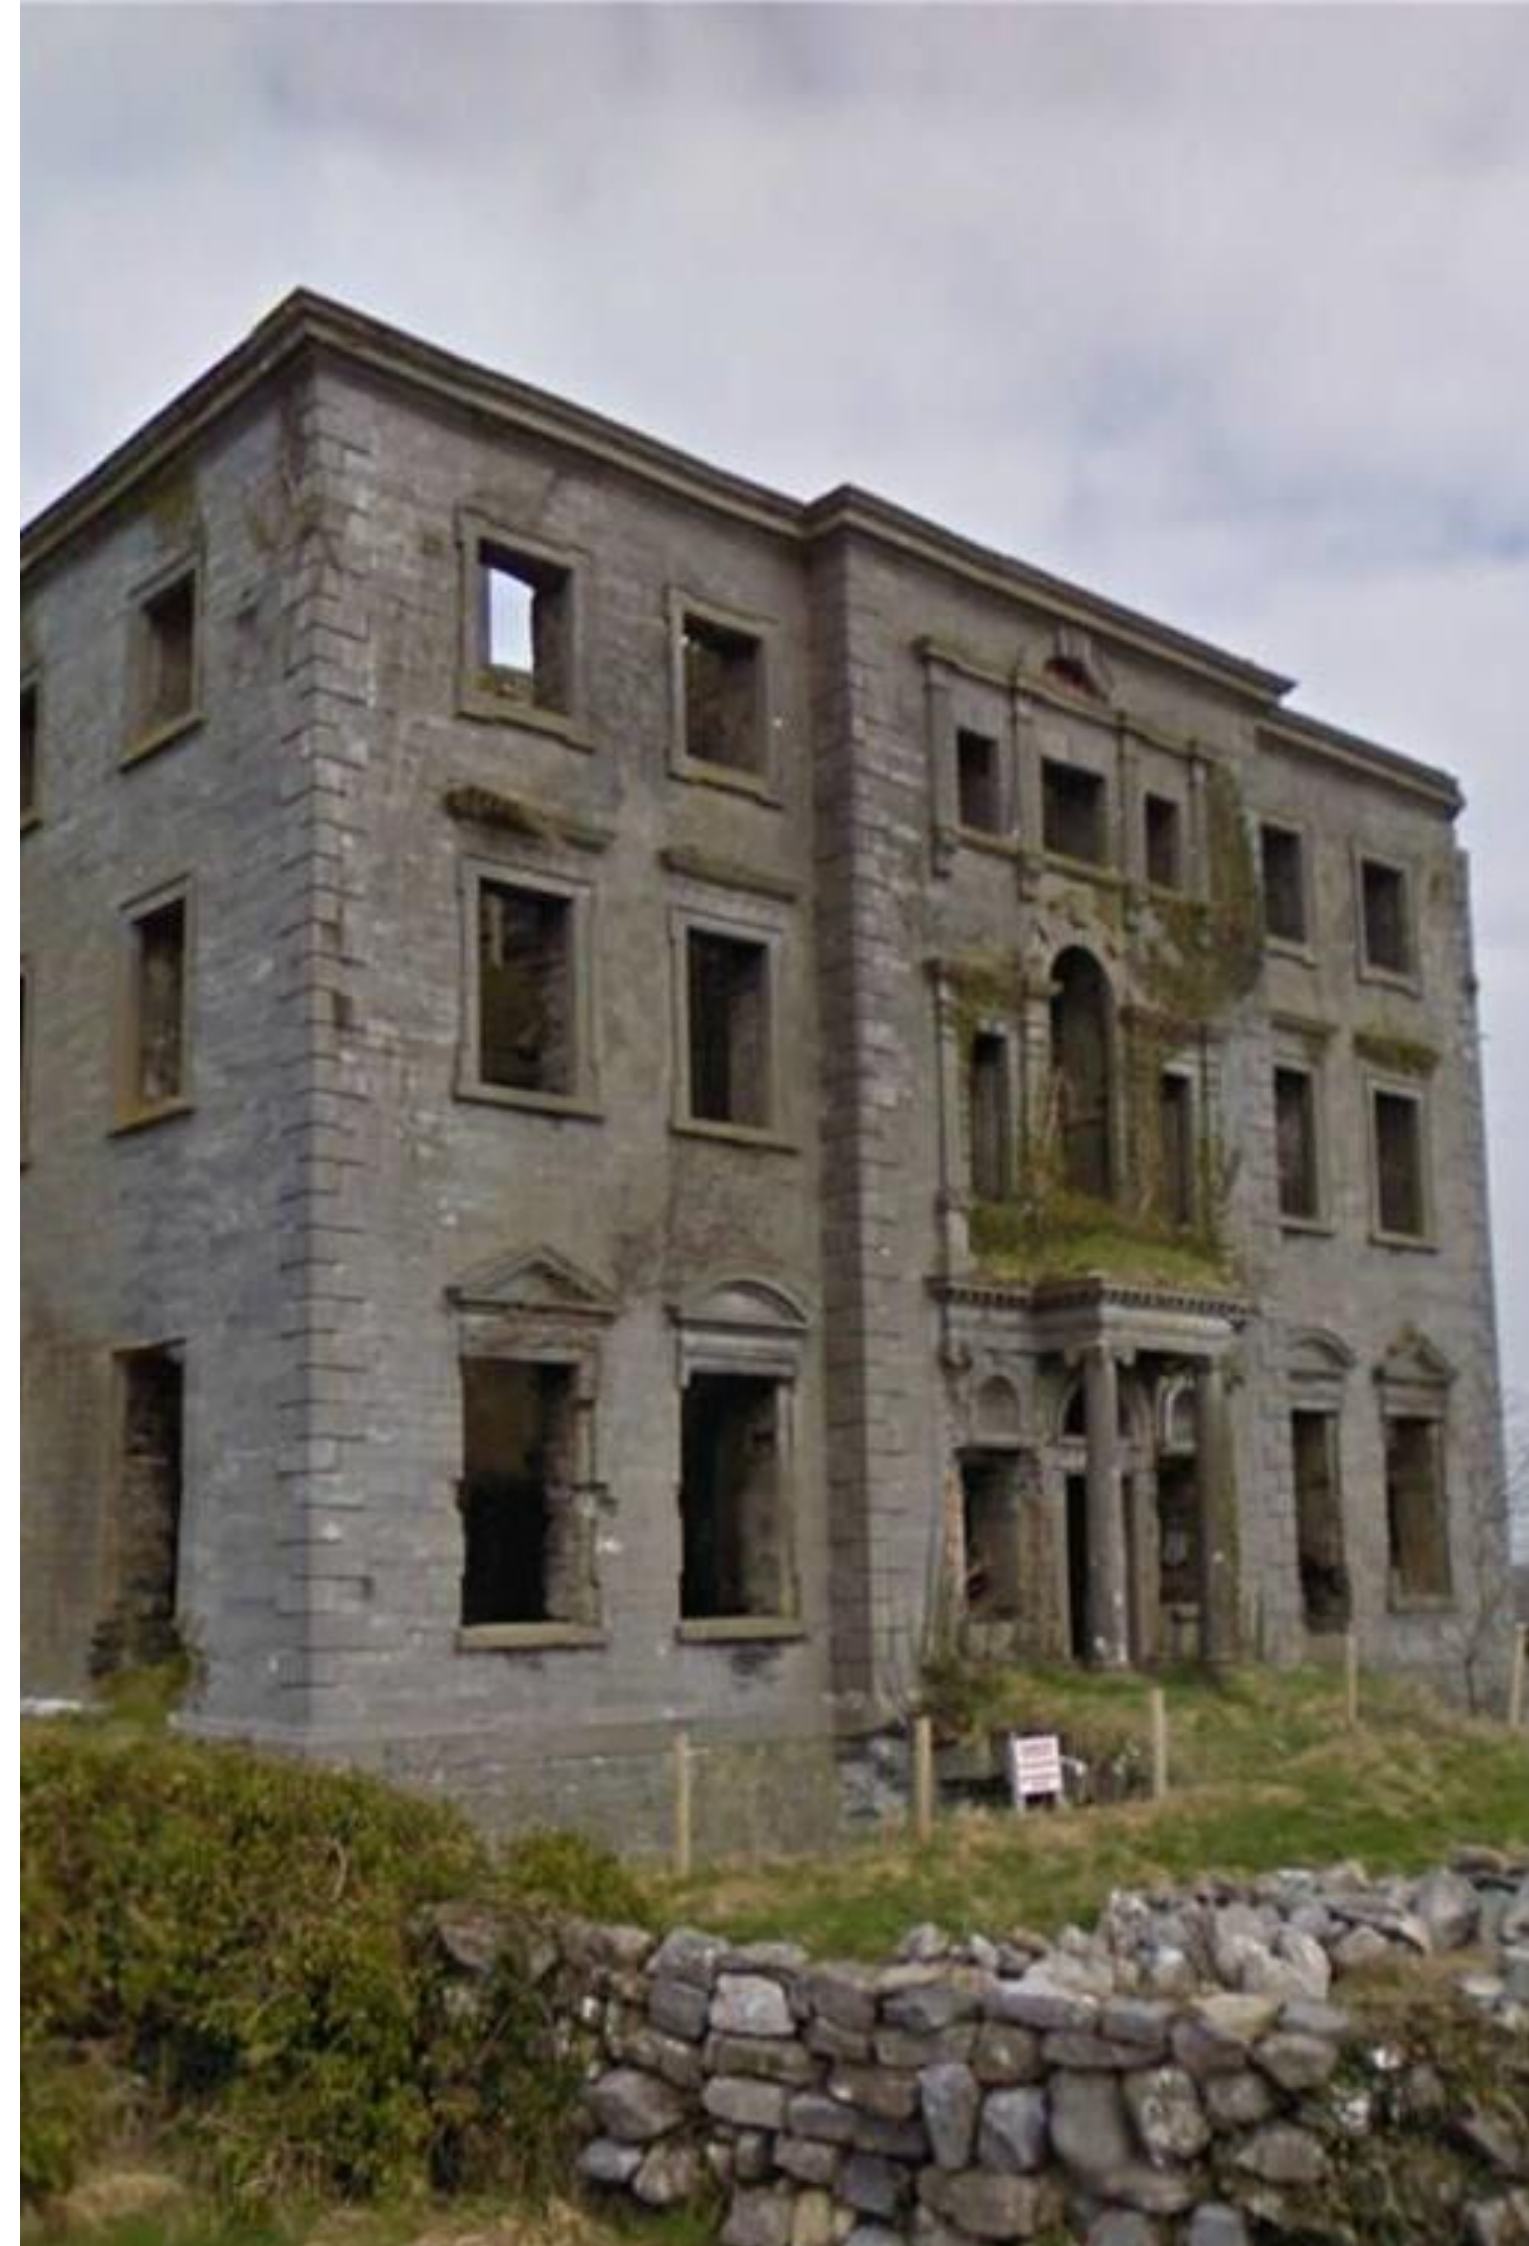
Ardfry House

Vacant with no identified new use	
Suffering from neglect and/or poor maintenance	
Suffering from structural problems	X
Fire damaged	
Threatened with demolition	
Ruin which is poorly maintained	X

Condition of Structure	Ruinous
Level of Risk	High

The building is a roofless shell. None of the original fabric remains other than the external walls. It is suffering from structural problems that could lead to full or partial collapse, and there is an immediate threat of further deterioration.

The house dates to circa 1770 and belonged to the Blake Family with later alterations. It adjoins the earlier medieval castle. The house has been in ruins since the mid 20th century. A development for works at this site was granted permission in 2004 by Galway County Council, however, this has not proceeded. The structure is of significant historic importance and requires conservation works to prevent further deterioration.

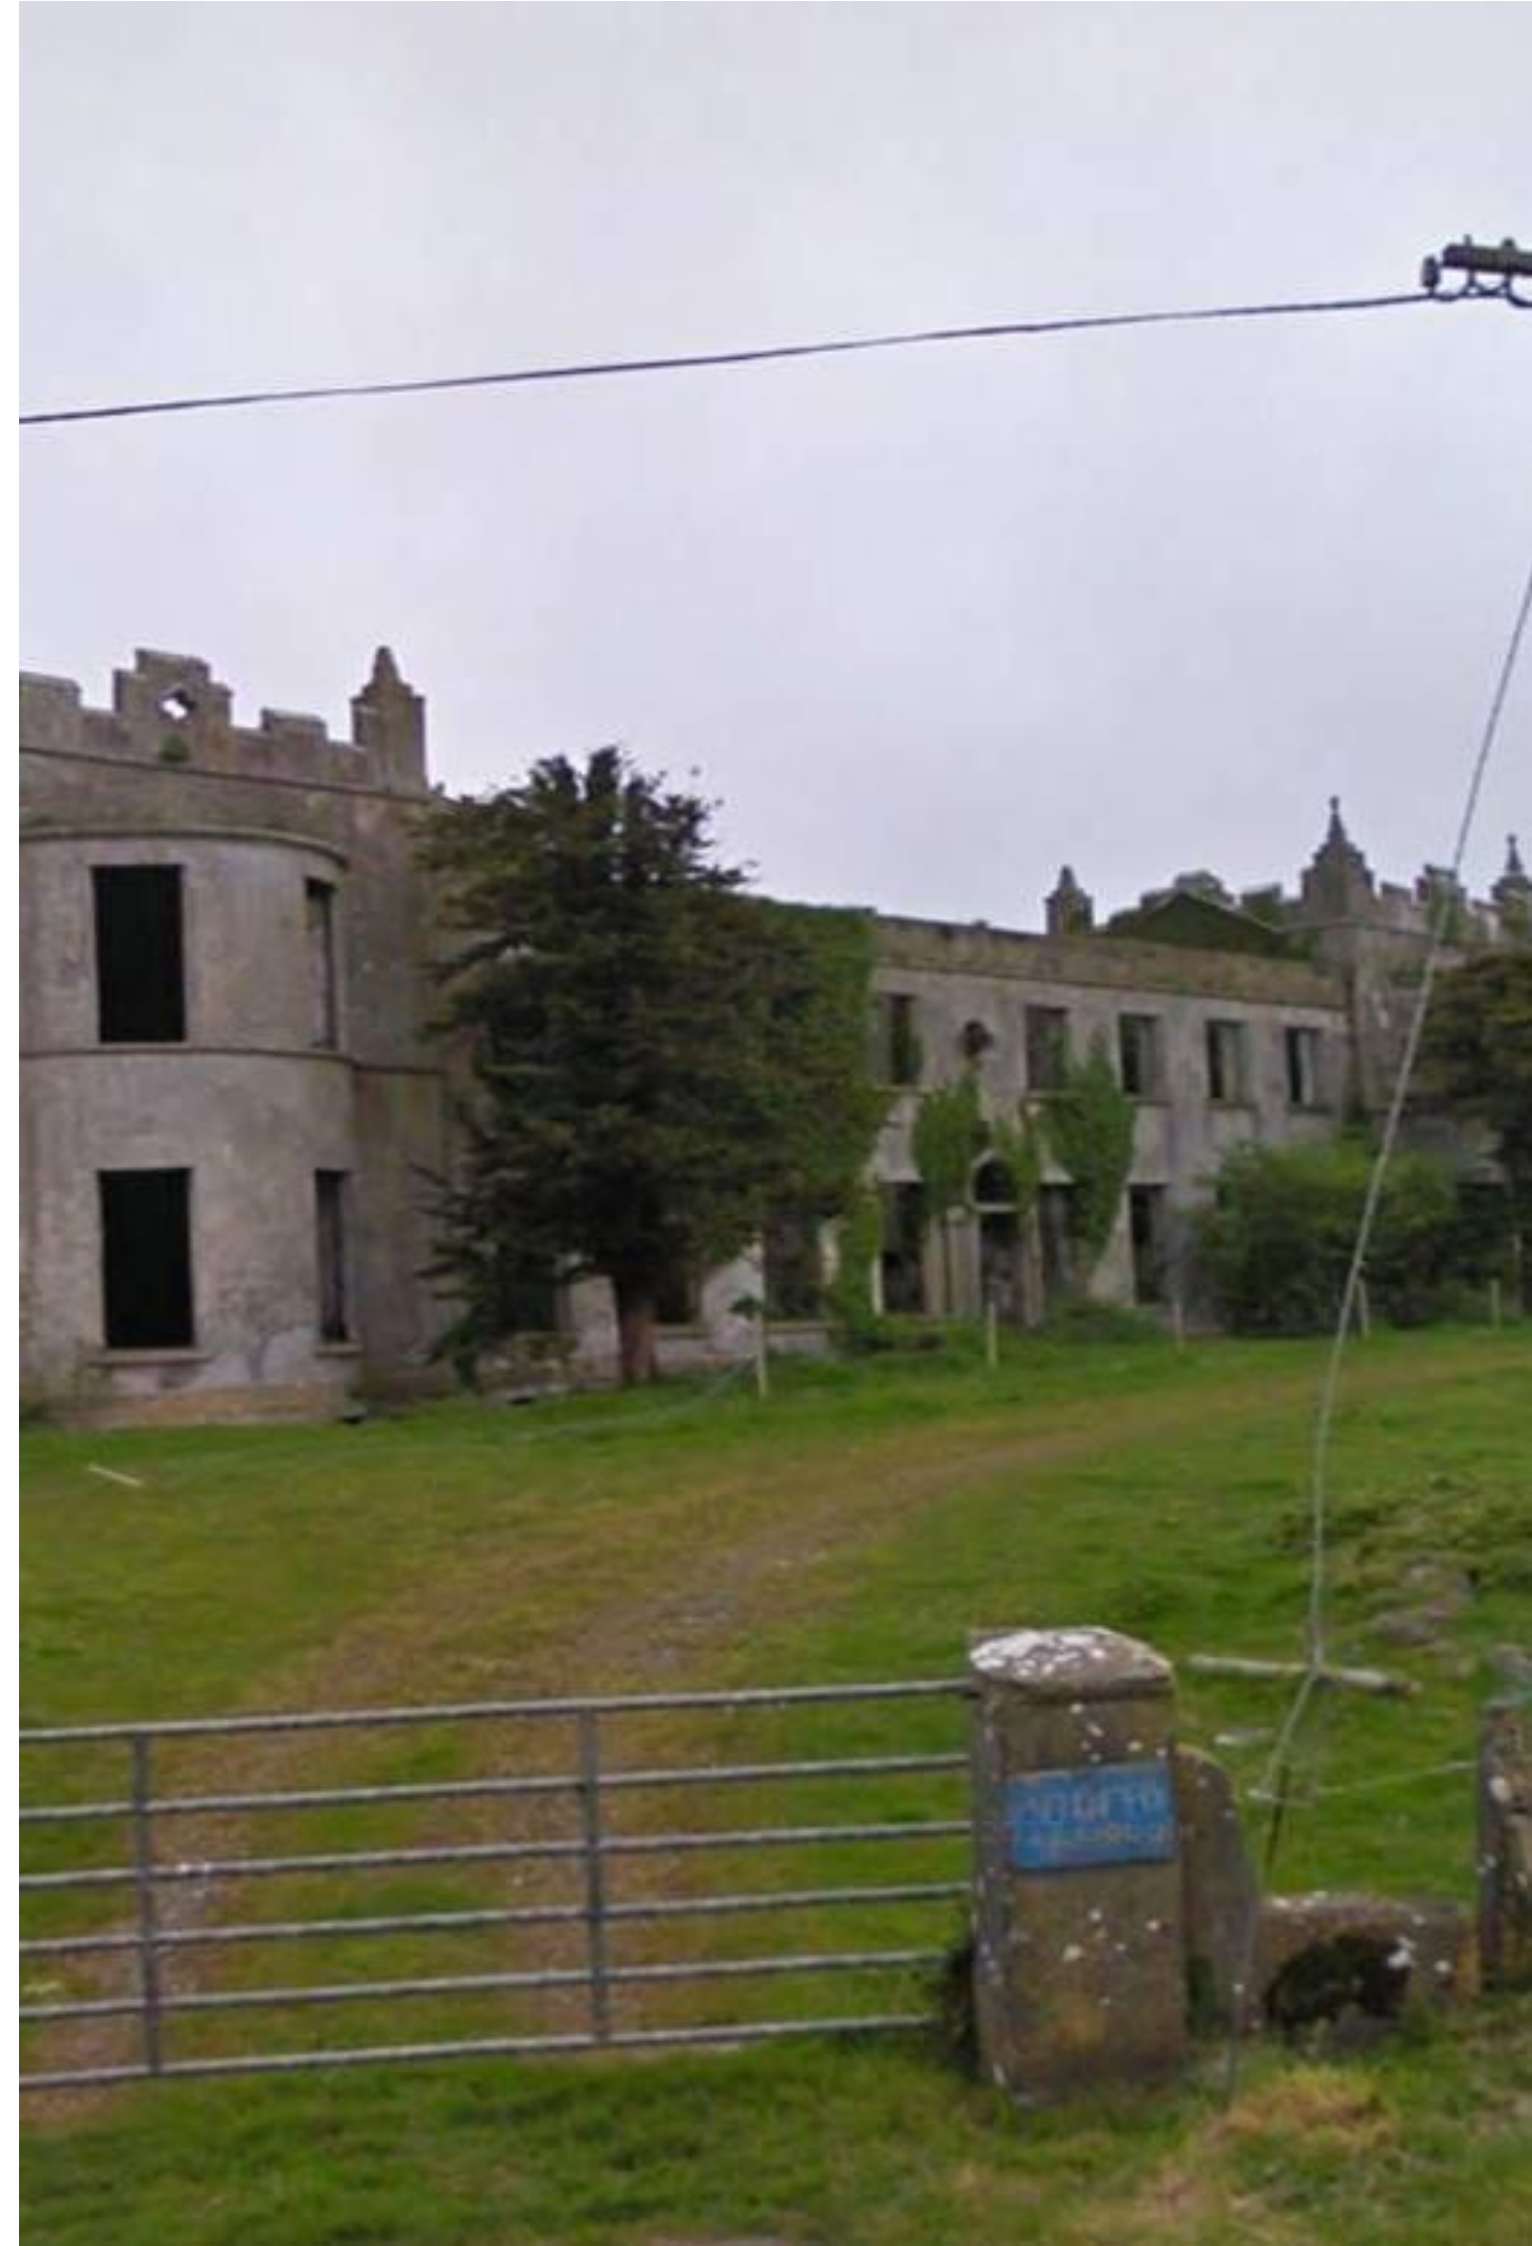
Woodlawn House

Vacant with no identified new use	X
Suffering from neglect and/or poor maintenance	X
Suffering from structural problems	
Fire damaged	X
Threatened with demolition	
Ruin which is poorly maintained

Condition of Structure	Very Poor
Level of Risk	High

The building is suffering from major conservation problems. Most of the external fabric remains, but there are obvious signs of deterioration such as slipped slates, vegetation growth, broken windows and vandalism. There is no immediate danger of collapse but condition is such that unless urgent remedial works are carried out the building will sharply deteriorate.

The building which was home to the Trench family has been vacant for over 40 years now, The building has been exposed through serious fire damage and is currently in the ownership of a local farmer. The Heritage Council had released funding for emergency repairs. This building urgently requires new uses to be identified to prevent further deterioration of its character.
